# PRELIMINARY ASSESSMENT OF THE NATIONAL GUARD FACILITIES AT FORT PICKETT, BLACKSTONE, VA

Engineering Technologies Associates, Inc. performed a Preliminary Assessment (PA) of the Federally-owned Virginia Army National Guard (VAARNG) areas of Fort Pickett located adjacent to Blackstone, Virginia, including a site visit and review of all available documents. The VAARNG areas of Fort Pickett are located in the Mobilization and Training Equipment Site (MATES) area. The VAARNG MATES facility mission is to provide support maintenance to Army National Guard and U.S. Army Reserve equipment on Fort Pickett.

**APPENDIX A**  
**Photographic Log**  
**(Photos taken January 19, 1994)**

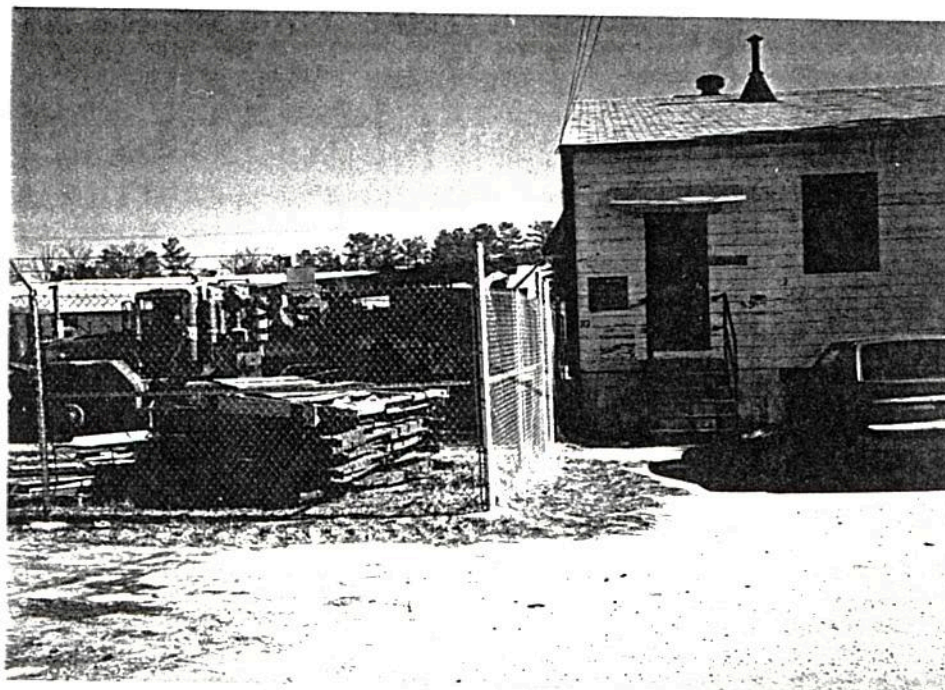
Building 113 is a wooden structure built in the early 1940's that was used by the VAARNG from 1961 to approximately 1987 when its storage function was transferred to the newly constructed Basic Issue Items building (Building 147). The VAARNG used this building as a storage area for vehicle components and parts. This building currently houses the U.S. Property and Fiscal Office (USP&FO) and is used to store unserviceable repair parts. Although this building is not located on land that is licensed to the VAARNG, the building itself is hand-receipted from the U.S. Army Garrison, Fort Pickett, to the VAARNG (see Photo 1) (Paulette, 1994) (All photographs are provided in Appendix A.)

Photo 1: Building 113, facing east.

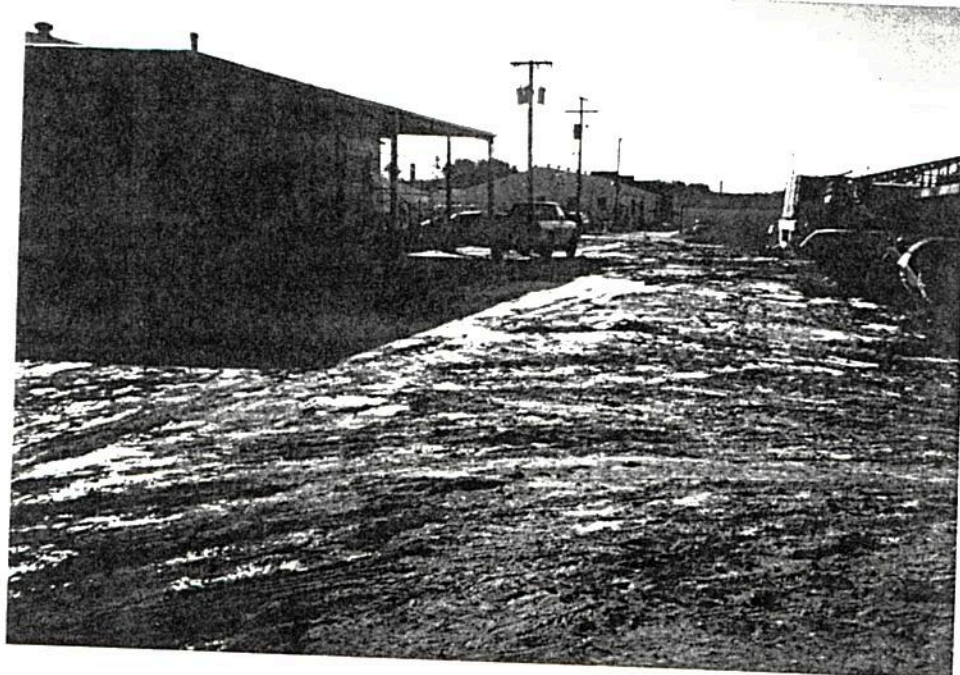
Building 124 was used by the VAARNG from 1961 to approximately 1988 when its warehouse function was transferred to the newly constructed VAARNG MATES facilities in Building 142. The VAARNG used this building to store repair items and parts. Since 1988, this building has been used by fielding teams for new M-1 tanks. These fielding teams accept shipments of new tanks from the manufacturer and perform acceptance inspections prior to distribution to U.S. Army, National Guard, and Reserve units (see Photo 3) (Paulette, 1994).

Photo 3: Building 124, facing south.

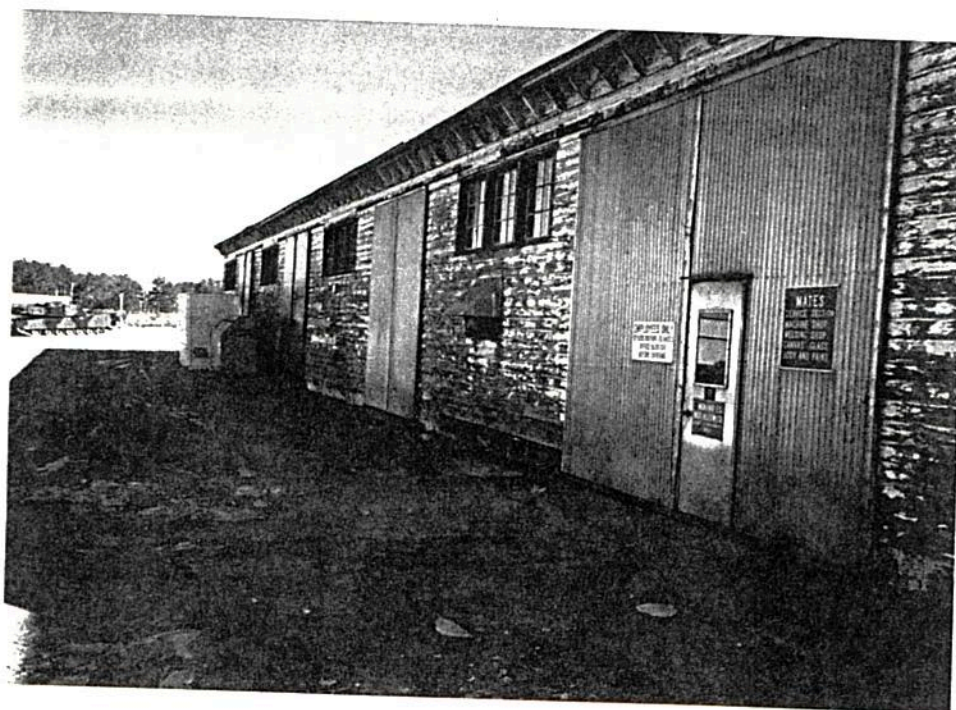
Building 127 houses a service section used by the VAARNG MATES facility (see Photo 4). A large paint booth is located in this building (see Photo 5), as well as a vehicle track repair shop. The paint booth was transported from Fort Eustis in 1974 or 1975. The paint booth is used to apply chemical agent resistant coating (CARC). The booth is filtered, and the filters are removed and replaced as required. No permit is required for this booth, and the spent filters are disposed of as non-hazardous solid waste. Tracked vehicles are driven into the building and the track is removed from the vehicle and repaired (Paulette, 1994). The building contains a Safety-Kleen parts wash station (see Photo 6). Safety-Kleen is a contract supplier of cleaning solvents, equipment, and services. The wash station unit is completely self-contained, and consists of a solvent storage drum and parts wash basin. It is serviced periodically by Safety-Kleen, who is located at 1200 West 100 Road, Chester, Virginia (Transportation, Storage, and Disposal Facility (TSDF) No. VAD 981043011) (Dudley, 1994).

Photo 4: Building 127, facing north.

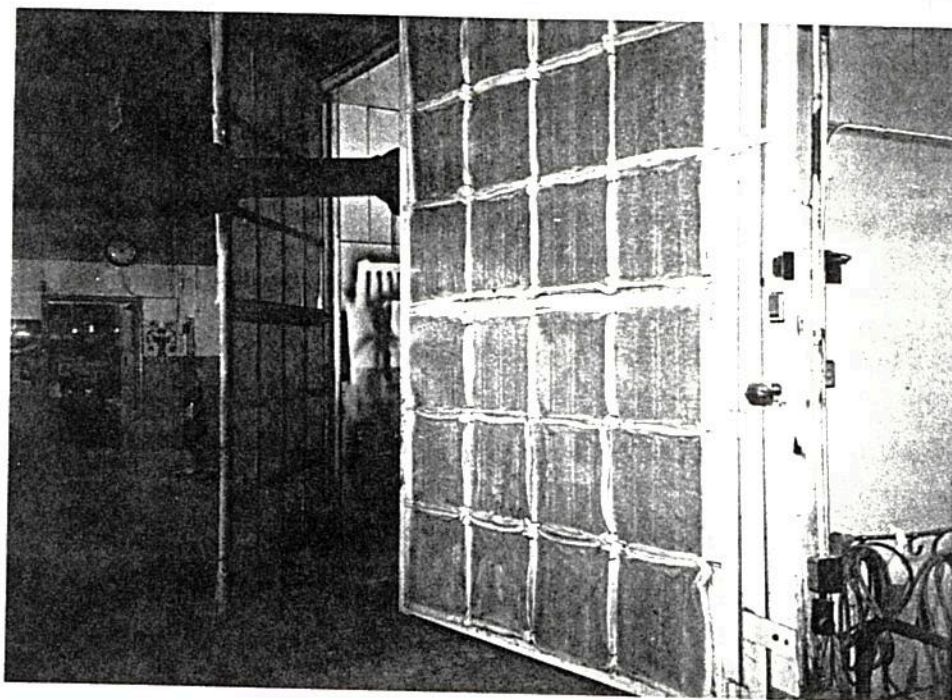
Photo 5: Paint booth inside Building 127.

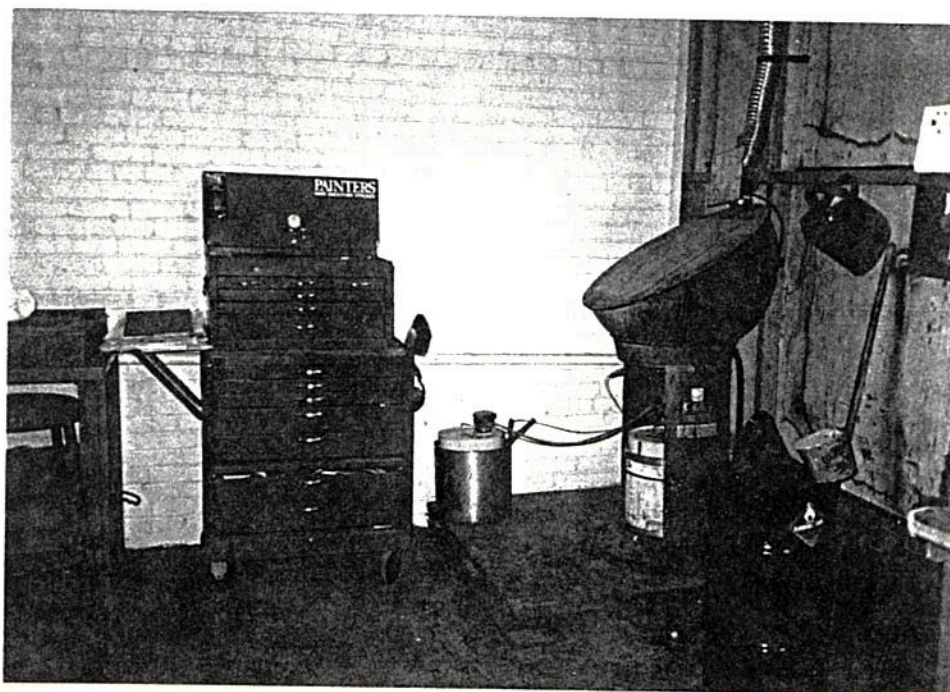
Photo 6: Safety-Kleen parts cleaning station inside Building 127.

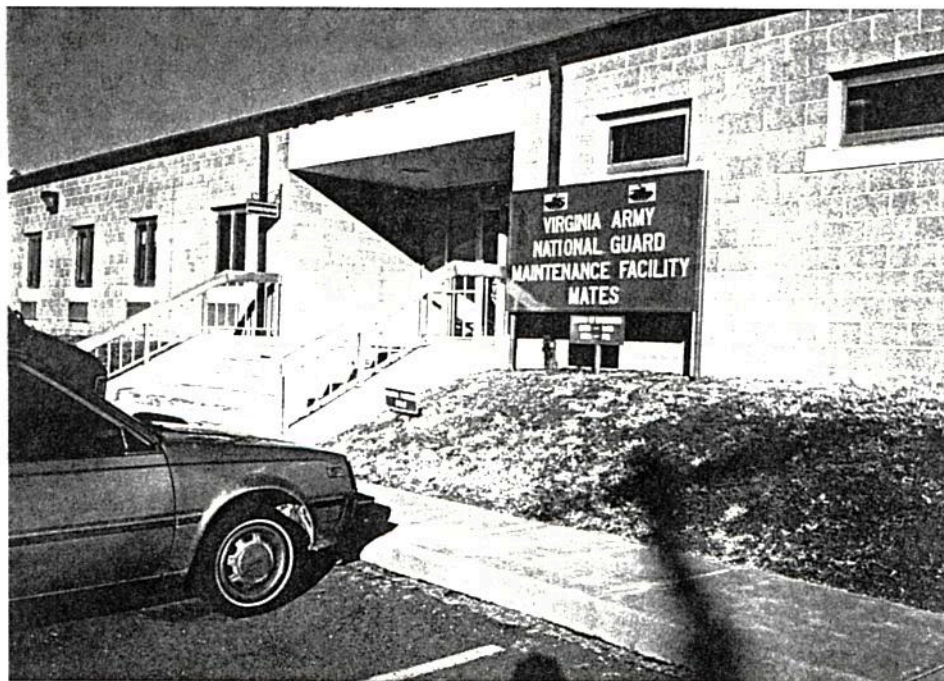
Building 134 is the main VAARNG MATES facility building and was constructed between 1985 and 1987 (see Photo 9) (Paulette, 1994). It is VAARNG property (Duke, 1994). The walls are constructed of concrete block and the floors are concrete. The south wing houses 13 repair bays where maintenance is performed on tracked vehicles (Paulette, 1994). In addition, the south wing contains a carburetor repair room, a battery room, and a tool room. Each repair bay is served by a floor drain which is connected to the sanitary sewer after being routed

Photo 9: Building 134, western entrance.

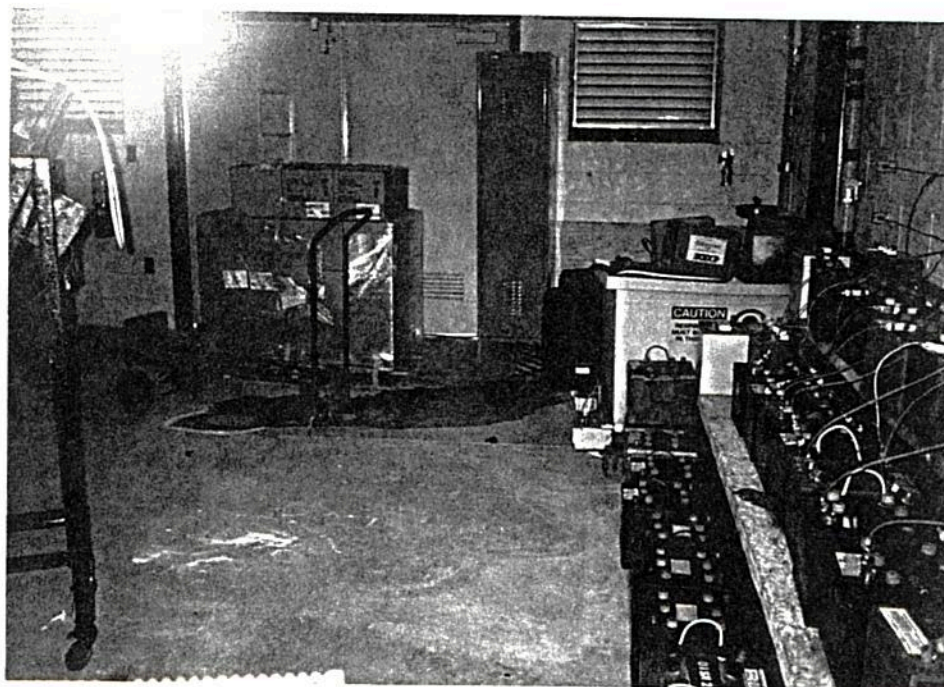
The Battery Room in the south wing of Building 134 contains a large number of lead-sulfuric acid batteries. For purposes of estimation, each battery is assumed to contain approximately 1 gallon of liquid. The temporary bulk storage of sulfuric acid outside the Battery Room amounts to an additional 225 gallons of a hazardous substance.

Photo 10: Buildings 134, Battery Room.

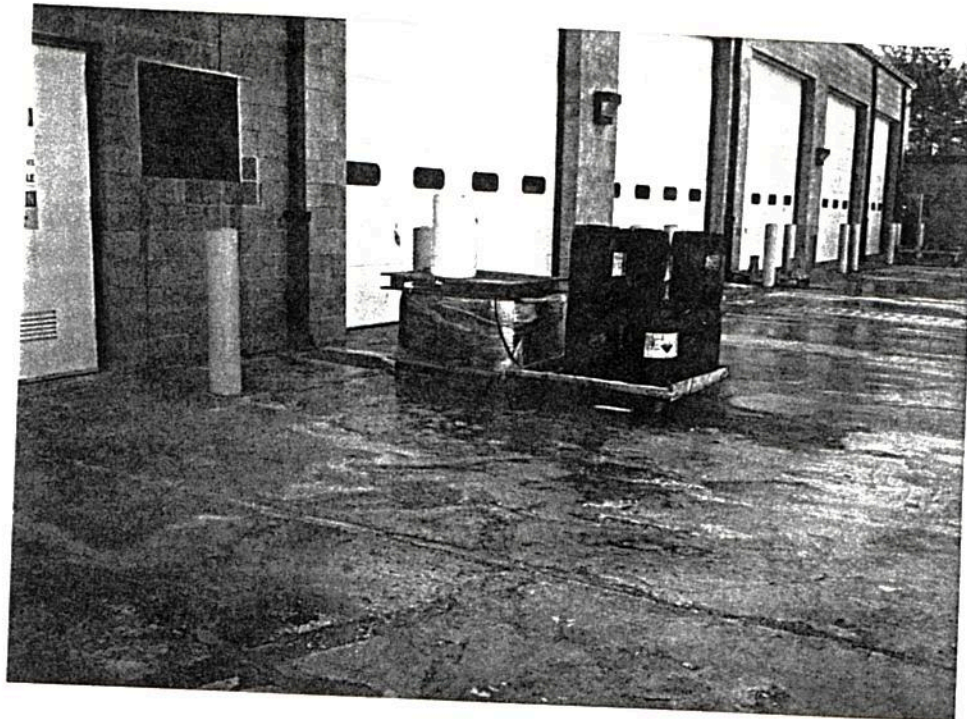
Photo 11: Building 134, sulfuric acid storage outside Battery Room.

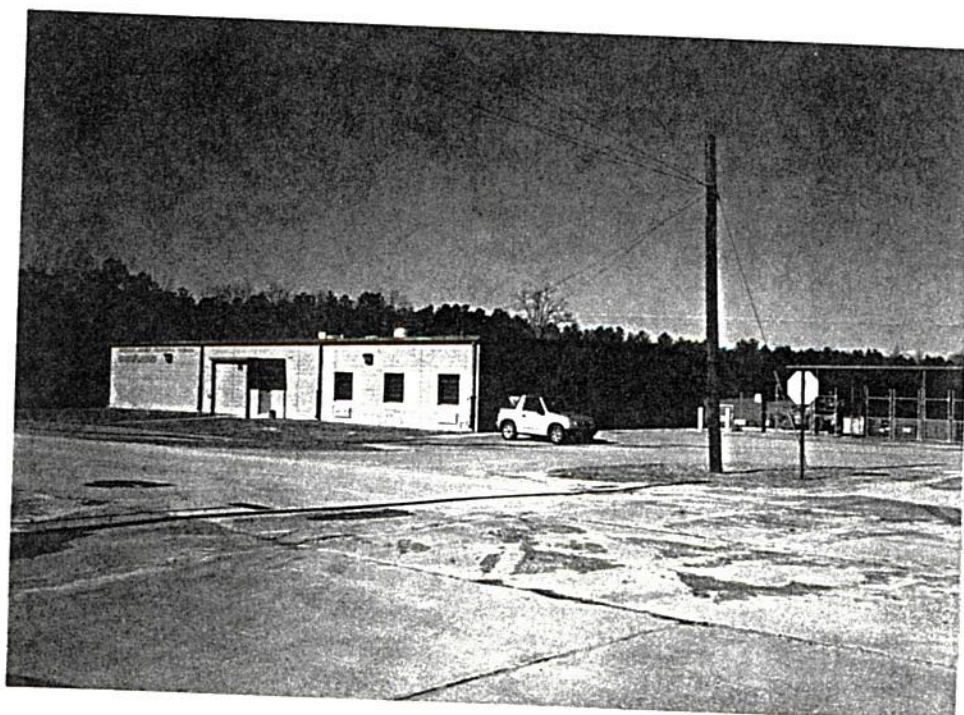
Building 142 is a concrete block structure with a concrete floor that was built at the same time as the new central VAARNG MATES facility (Building 134). The operations and activities from Buildings 124 and 125 were consolidated in this new facility. The VAARNG uses this building to store repair items and parts (see Photo 16) (Paulette, 1994). Building 142 is VAARNG property (Duke, 1994).

Photo 16: Building 142, facing northwest.

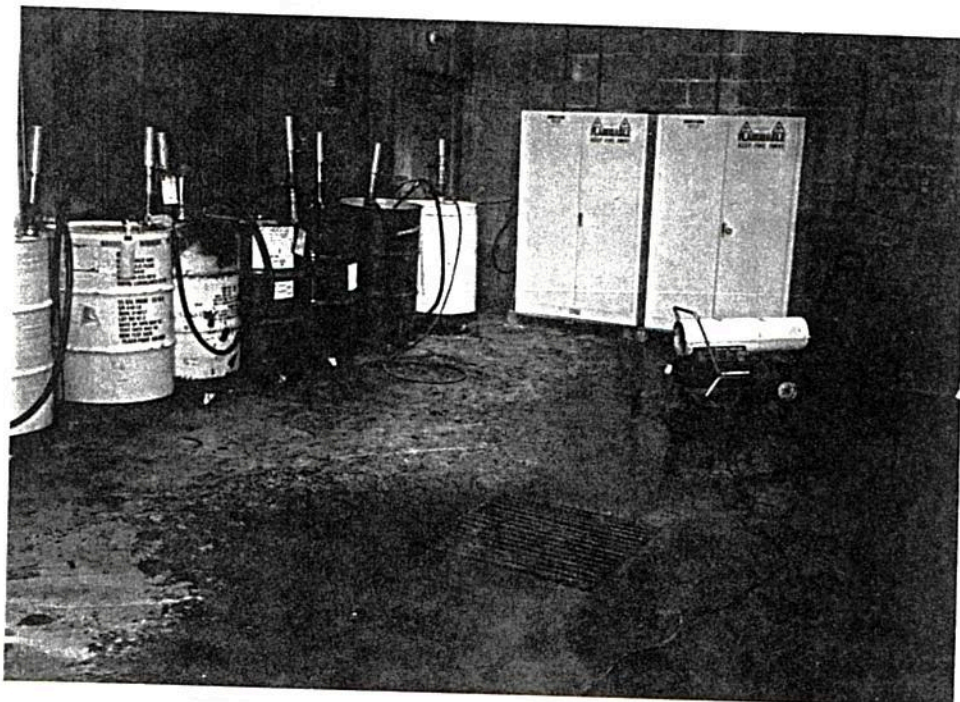
Photo 18: Building 143, washrack, floor drain, flammable storage locker.

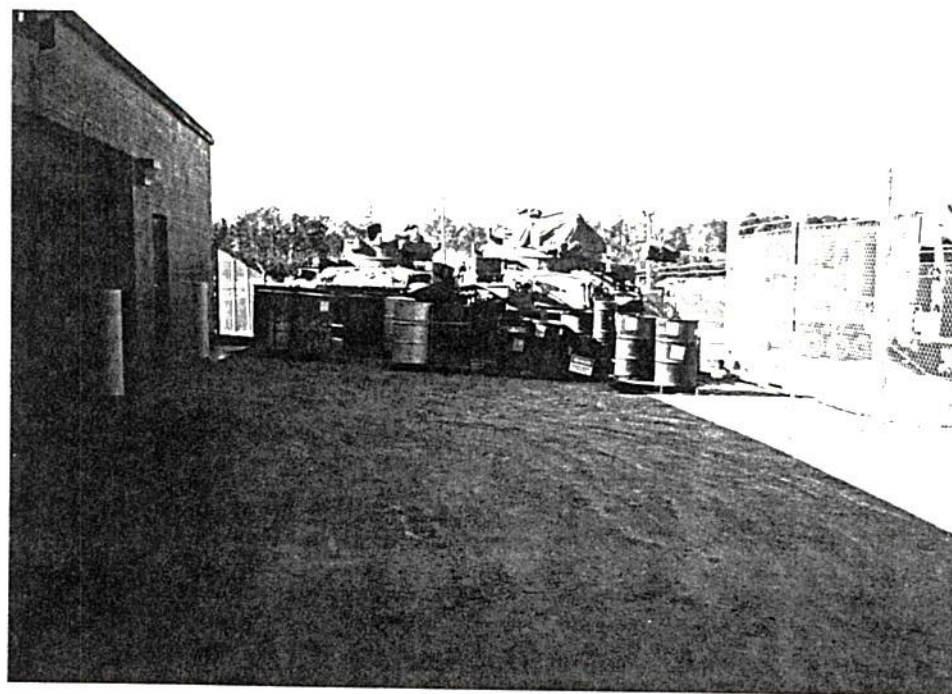
Photo 21: Building 147, hazardous waste storage area.

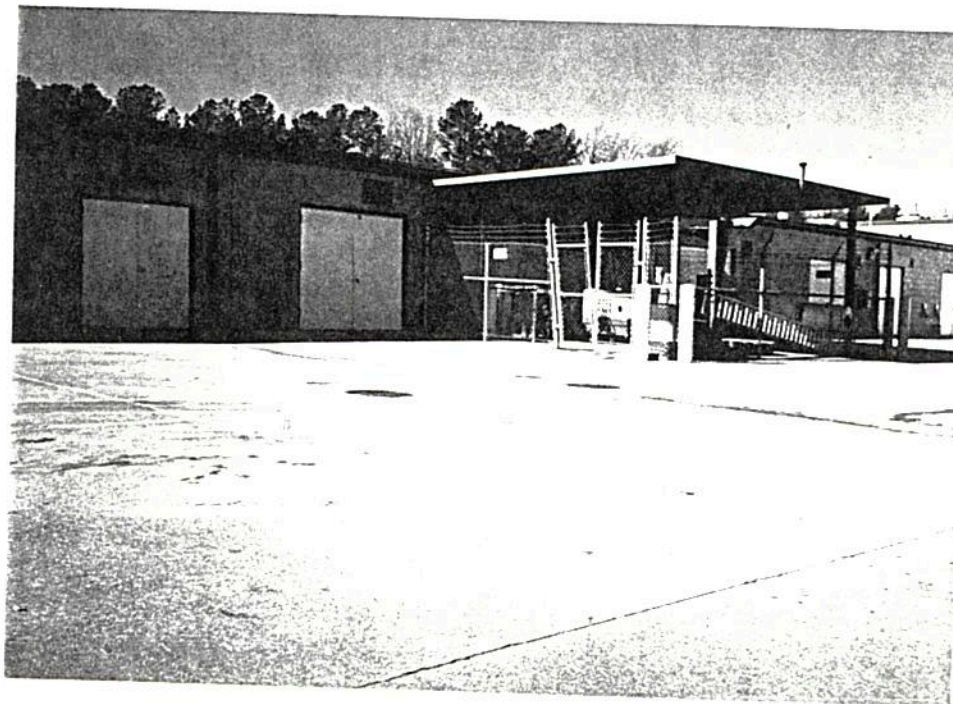
Used oil from operations in Building 134 is routed to an underground storage tank (UST) for temporary storage. The used oil is then mixed with virgin heating oil and burned to provide heat for Building 134 (Paulette, 1994).

Photo 25: Building 134, used oil UST in center courtyard.
